**PRECURSOR DAMAGE EVOLUTION AND STRESS
CORROSION CRACK INITIATION OF COLD-WORKED
ALLOY 690 IN PWR PRIMARY WATER**

**Technical Milestone Report: M2LW-16OR0402034
September 2016**

Research Project:
**Stress Corrosion Crack Initiation of
Nickel-Base Alloys in LWR Environments**
Project Manager: S. M. Bruemmer
Pacific Northwest National Laboratory

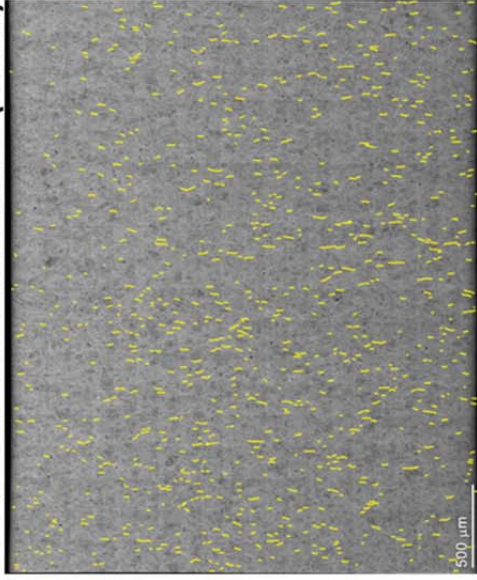
TT + 31%CF Sumitomo CRDM (IN033)

TT + 31%CF Valinox CRDM (IN038)

TT + 31%CF Sumitomo CRDM (IN034)

TT + 31.9%CF TK-VDM Plate (IN044)

Figure 102. SEM-BSE montage images of the gauge section of four 31-32% alloy 690TT specimens with aggregations of GB cavities highlighted in yellow.
